Structure Number: 18
Original Use: Housekeeping Quarters
Present Use: Personnel Quarters
Construction Date: 1916
Architect: Unknown
Number of Levels: Four (including basement and storage attic)
Total Area: 7,370 square feet
Plan Shape: Rectangular
Basic Construction: Wood framing
Uses per Floor: Basement

-NHL Nomination, Northwestern Branch, National Home for Disabled Volunteer Soldiers (2010)

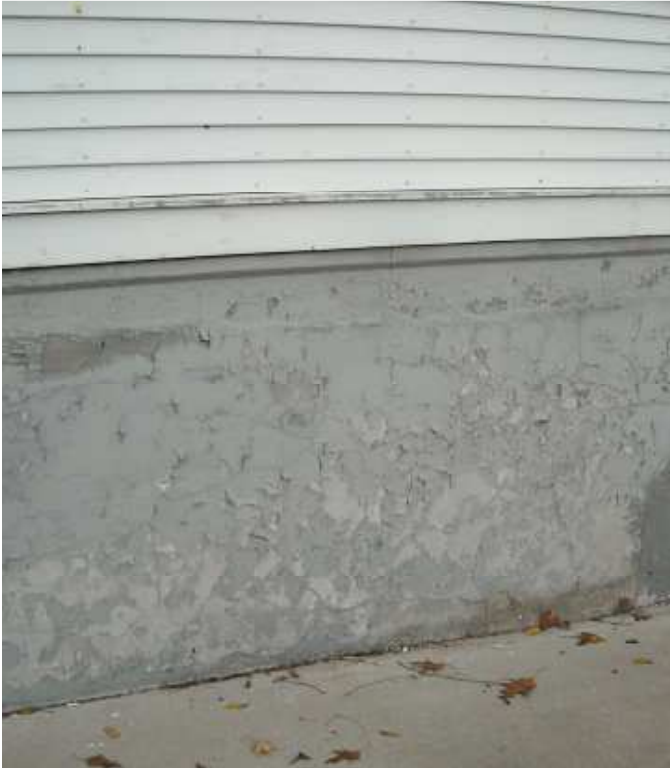
1 Peeling paint at concrete foundation wall.

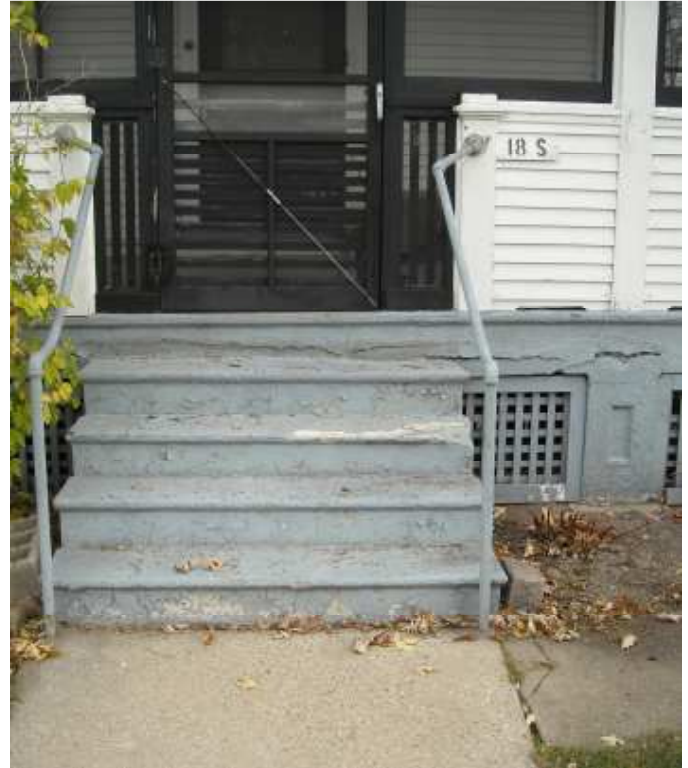
| EXTERIOR MATERIAL / FEATURE | PROBLEM IDENTIFIED | PROBLEM LOCATION | | | | | | | | | | | | | | | | | | RCMD | PHOTO |
|---|---|---|---|---|---|---|---|---|---|---|---|---|---|---|---|---|---|---|---|---|---|
| | Cracks or Pits in Concrete - Major | | | • | • | | | • | • | | | | | | | | | | | C2 | 2, 4 |

2 Peeling paint, cracks and pits at concrete stair and foundation.

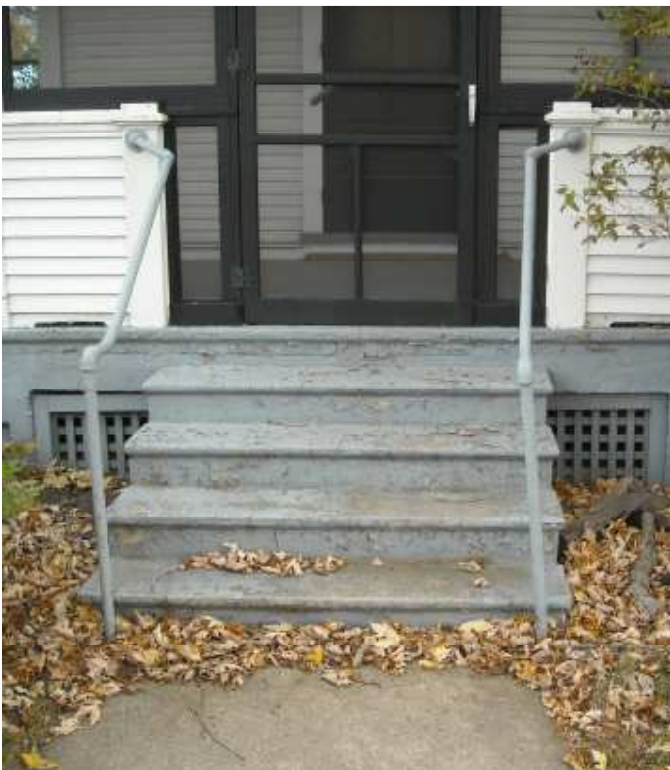
3 Peeling paint, cracks and pits at concrete stair.

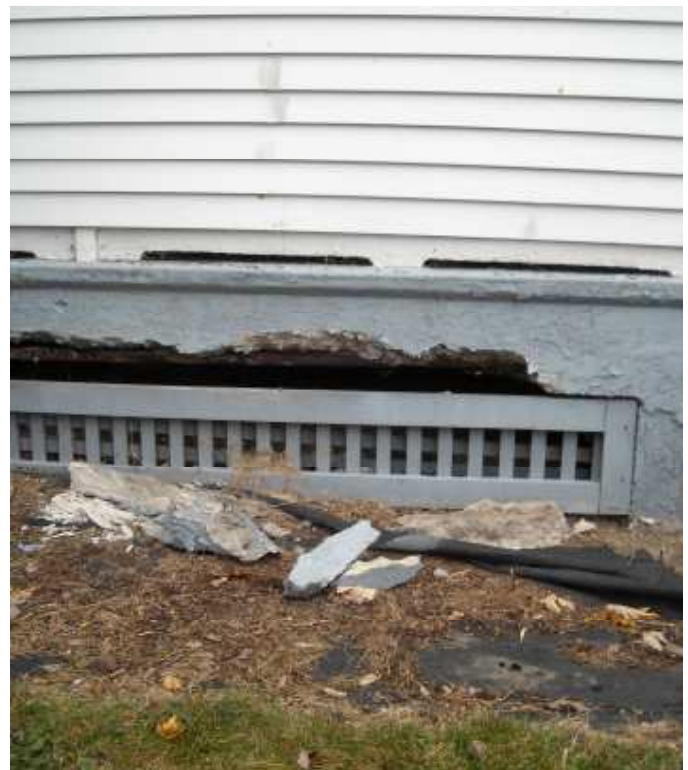
4 Spalling at concrete foundation.

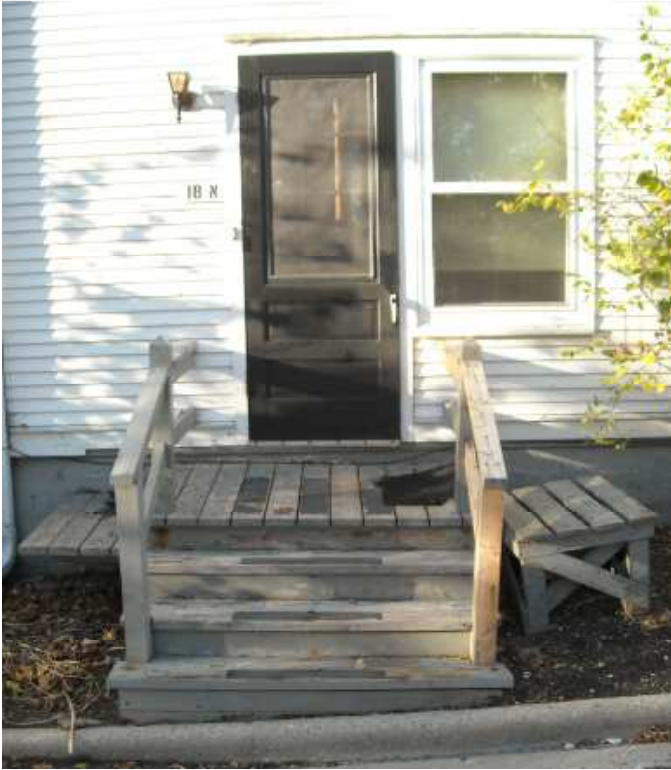
5 Unpainted wood porch.

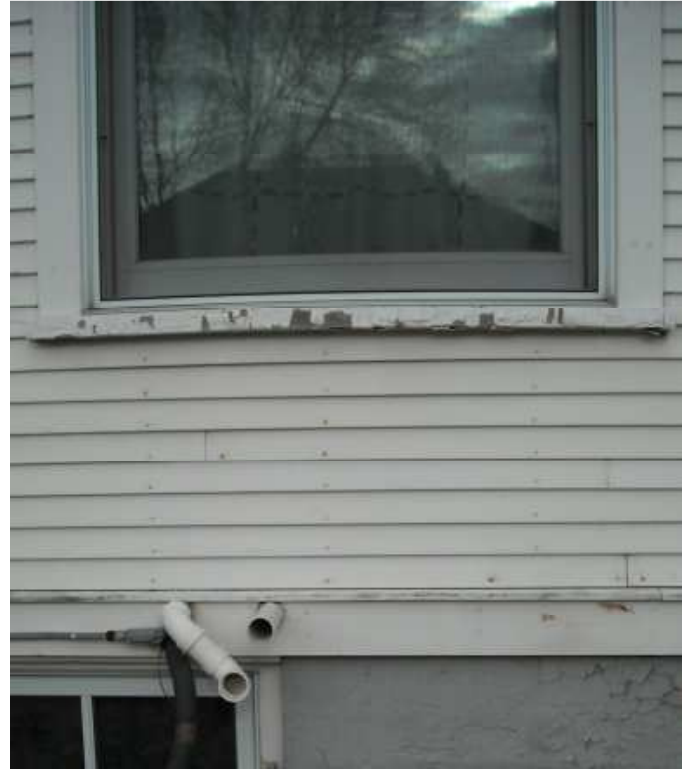
6 Peeling paint at window trim; aluminum storm windows installed at exterior.

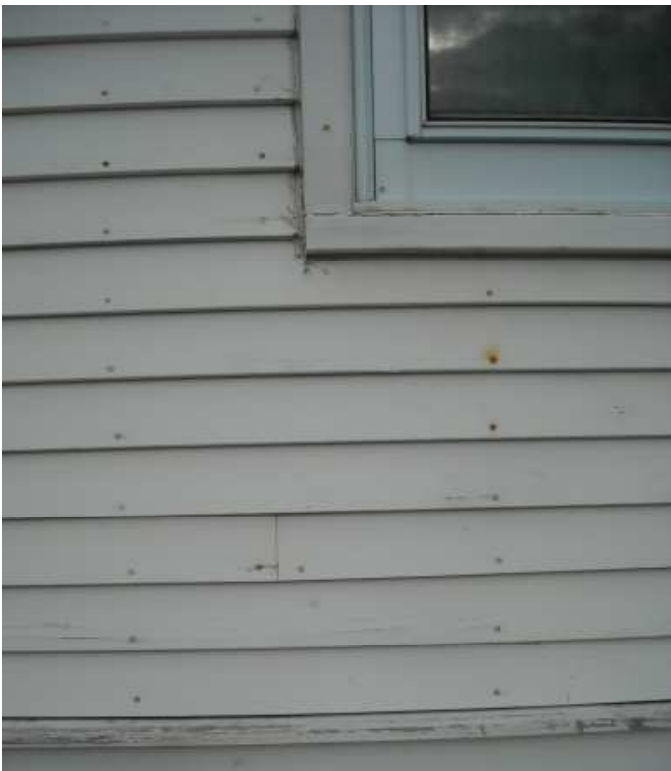
| EXTERIOR MATERIAL / FEATURE | PROBLEM IDENTIFIED | PROBLEM LOCATION | | | | | | | | | | | | | | | | | | RCMD | PHOTO |
|---|---|---|---|---|---|---|---|---|---|---|---|---|---|---|---|---|---|---|---|---|---|
| | Deteriorating Caulk | • | • | • | • | • | • | • | • | • | | | | | | | | | | O9 | 7 |

7 Exposed rusting fasteners at wood siding; deteriorating caulk at windows.

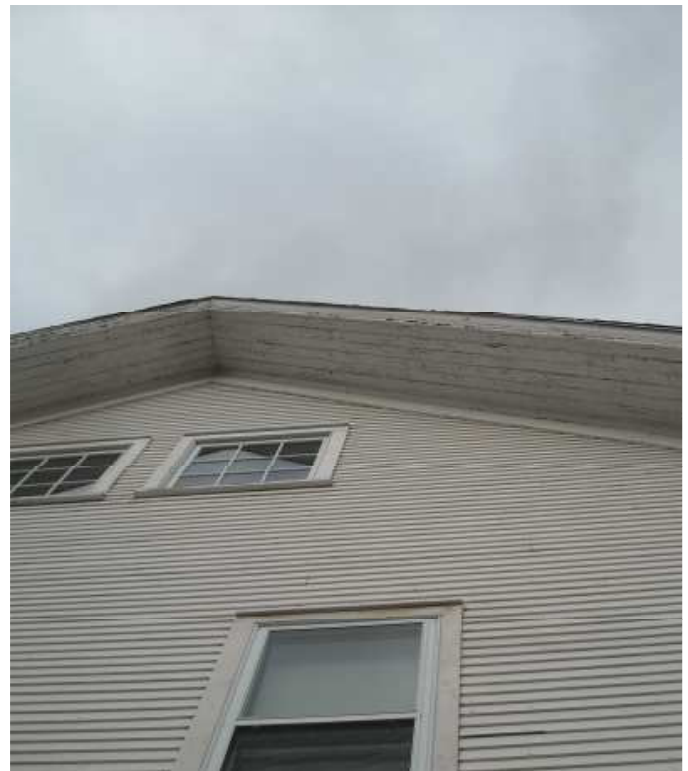
8 Peeling paint at soffits.

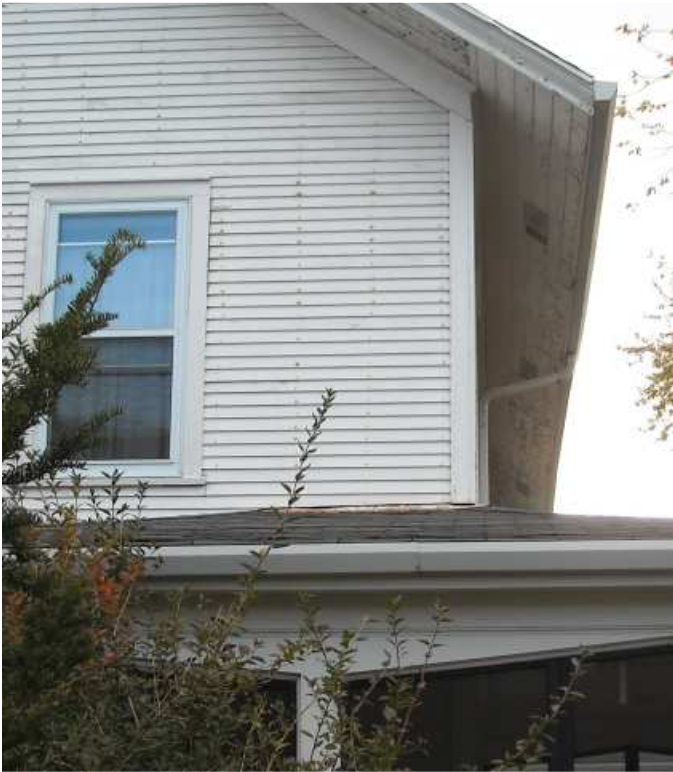
| EXTERIOR MATERIAL / FEATURE | PROBLEM IDENTIFIED | PROBLEM LOCATION | | | | | | | | | | | | | | | | | | RCMD | PHOTO |
|---|---|---|---|---|---|---|---|---|---|---|---|---|---|---|---|---|---|---|---|---|---|
| | Flashing Deterioration | • | • | • | • | • | • | • | • | • | | | | | | | | | | M4 | 9,10 |

9 *Deteriorating metal flashing; peeling paint at soffits.*

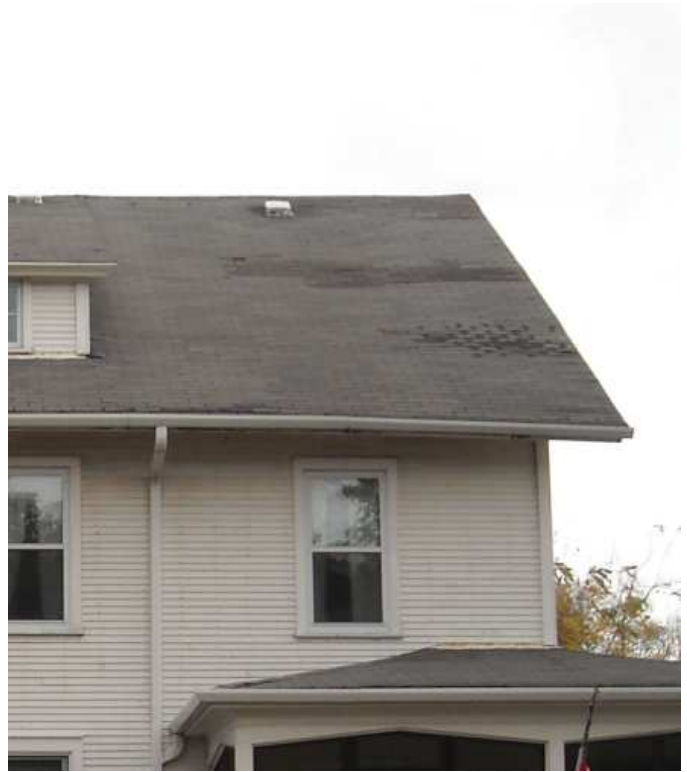
10 *Missing, damaged or worn shingles; sagging structure.*

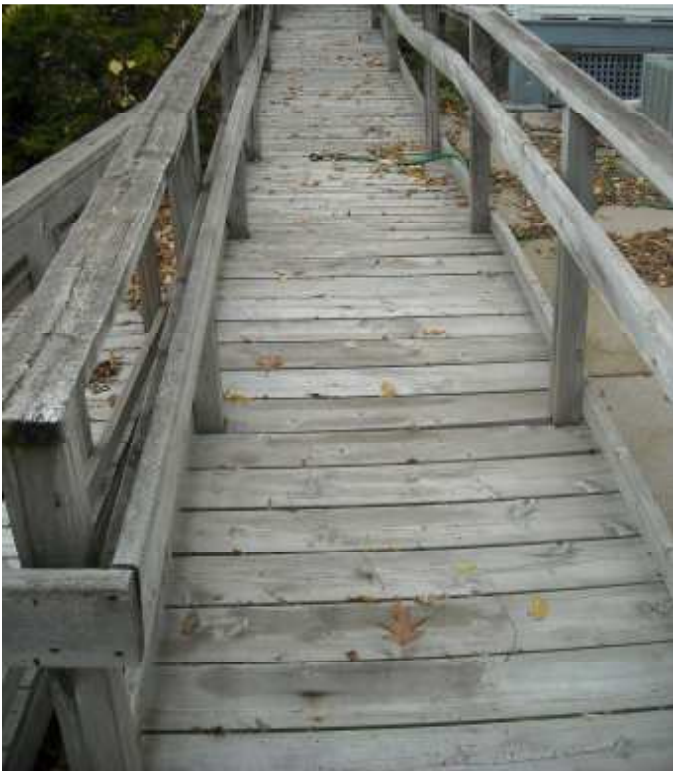
11 *Ramp unpainted and not compliant with current standards.*

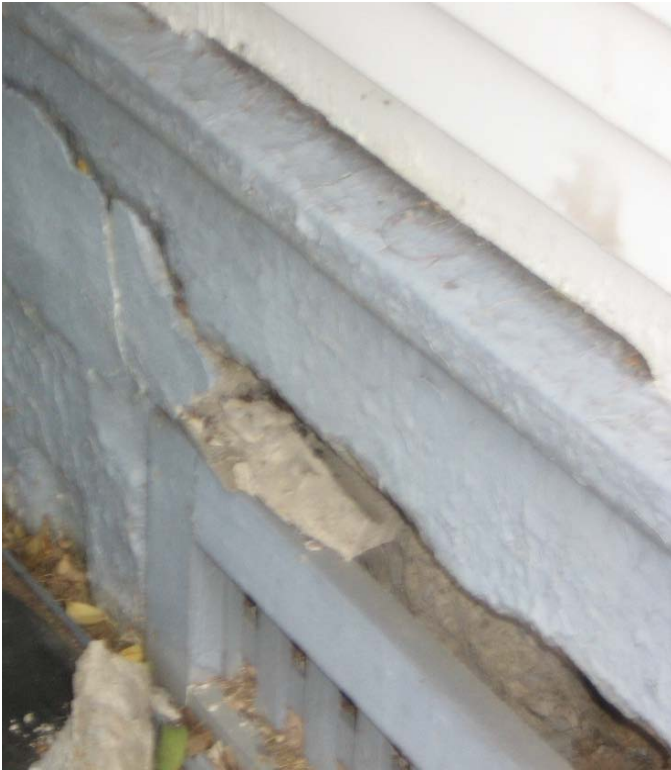
| EXTERIOR ITEM | PROBLEM IDENTIFIED | PROBLEM LOCATION | | | | | | | | | | | | | | | | | | | | RCMD | PHOTO | |
|---|--|---|---|---|---|---|---|---|---|---|---|---|---|---|---|---|---|---|---|---|---|---|---|---|
| Concrete Foundation Wall - Exterior | Wall Cracking - Minor | ● | ● | ● | ● | ● | ● | ● | ● | ● | ● | ● | ● | | | | | | | | | | C2 | 1, 4 |

Photo 1: Deterioration & Cracking at Existing Concrete Foundation Walls.

MODERATE REPAIRS ARE NEEDED FOR ALL THE FOUNDATION WALLS AS MINOR CRACKING TO THE EXISTING CONCRETE FOUNDATION WALLS HAS TAKEN PLACE. THIS IS TYPICAL OF ALL THE CONCRETE BUILDING FOUNDATION WALLS AS WELL AS THE PATIO FOUNDATION WALLS.

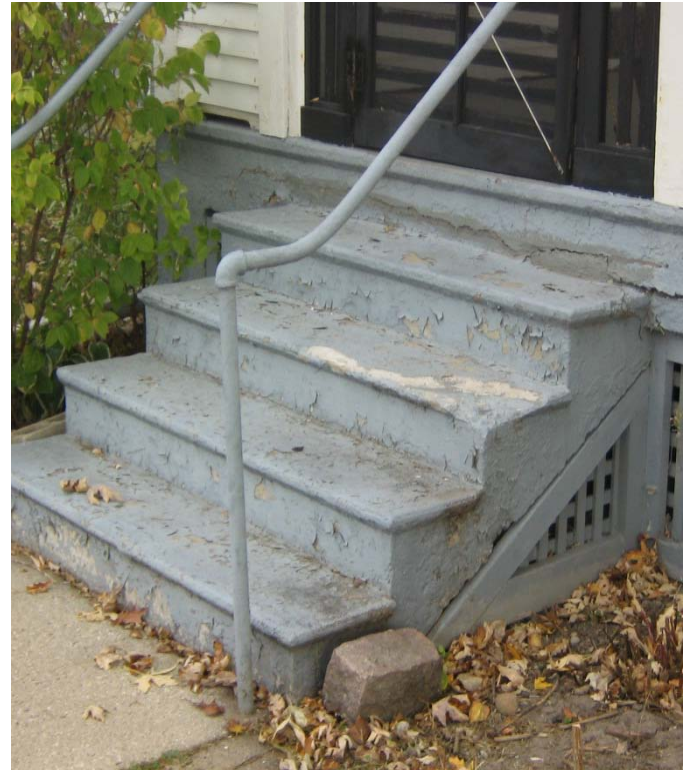
| EXTERIOR ITEM | PROBLEM IDENTIFIED | PROBLEM LOCATION | | | | | | | | | | | | | | | | | | | | RCMD | PHOTO | |
|---|--|---|---|---|---|---|---|---|---|---|---|---|---|---|---|---|---|---|---|---|---|---|---|---|
| Wood Floor Framing - Patio Stairs | Deterioration of Exterior Wood Stair - Minor | ● | | | ● | | | ● | | | | | | | | | | | | | | | W2 | 2 |

Photo 2: Deterioration of Exterior Wood Stair & Associated Framing.

MINOR REPAIRS ARE NEEDED FOR ALL EXTERIOR WOOD STAIRS & ASSOCIATED PATIOS. MINOR DETERIORATION OF THE EXPOSED WOOD HAS TAKEN PLACE OVER TIME. IT IS RECOMMENDED THAT THE EXPOSED PATIO STAIRS BE REFINISHED TO HELP PREVENT FURTHER DETERIORATION.

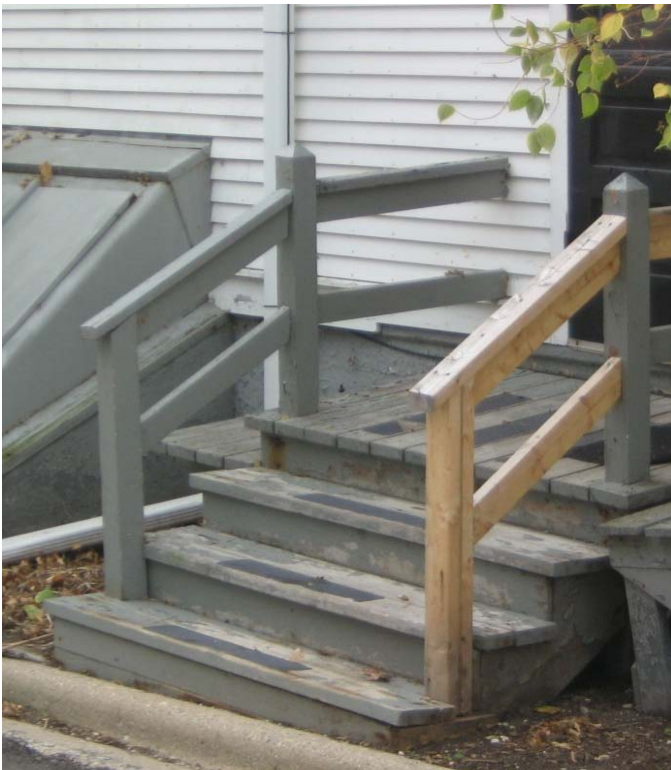
| EXTERIOR ITEM | PROBLEM IDENTIFIED | PROBLEM LOCATION | | | | | | | | | | | | | | | | | | | | RCMD | PHOTO | |
|---|--|---|---|---|---|---|---|---|---|---|---|---|---|---|---|---|---|---|---|---|---|---|---|---|
| Wood Floor Framing - Entry Stairs | Deterioration of Exterior Wood Stair - Minor | ● | | | ● | | | ● | | | | | | | | | | | | | | | W2 | 3 |

Photo 3: Deterioration of Exterior Wood Stair & Associated Framing.

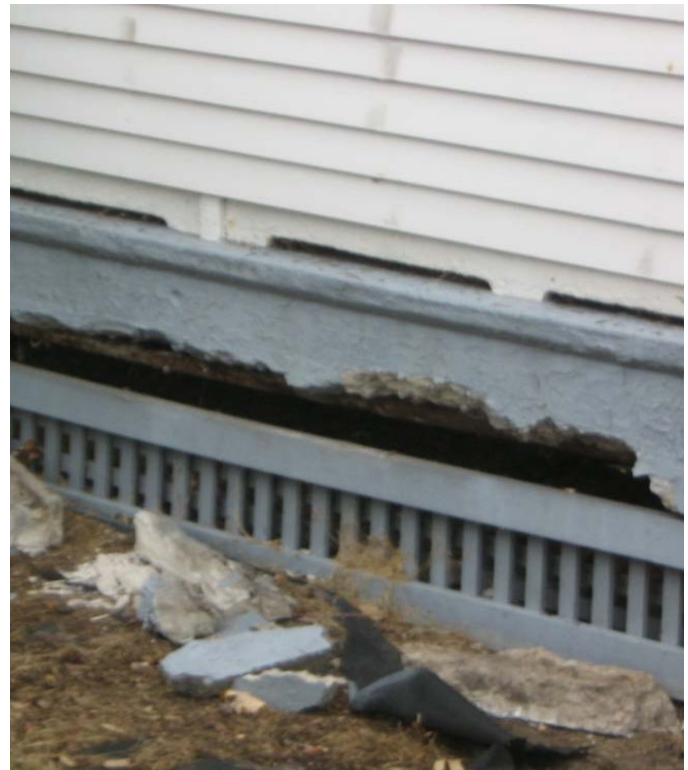
Photo 4: Deterioration & Cracking at Existing Concrete Foundation Walls.

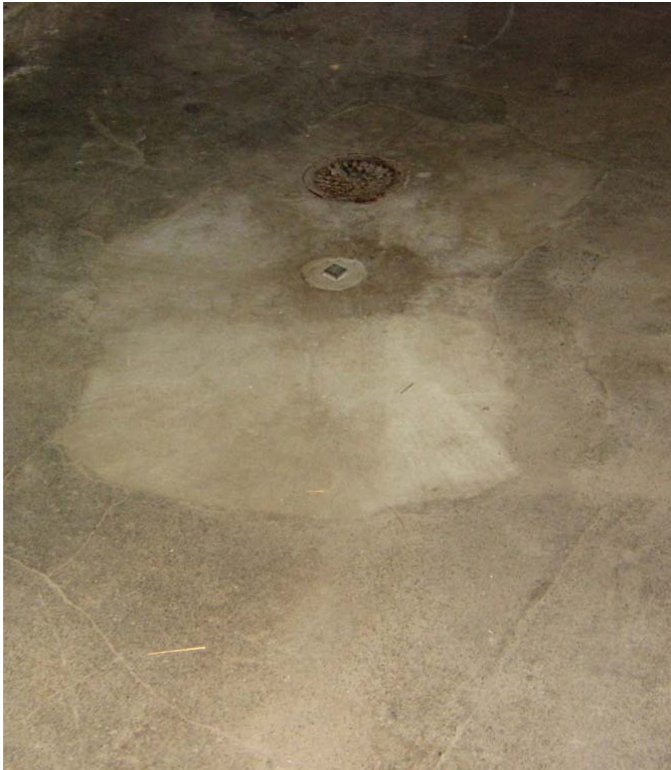
| INTERIOR ITEM | PROBLEM IDENTIFIED | PROBLEM LOCATION | | | | | | | | | | | | | | | | | | | | | | | | | | | | RCMD | PHOTO |
|--|---|---|---|---|---|---|---|---|---|---|---|---|---|---|---|---|---|---|---|---|---|---|---|---|---|---|---|---|---|---|---|
| Concrete Floor Slab - Basement | Floor Cracking - Minor | ● | ● | ● | | | ● | | | | | | | | | | | | | | | | | | | | | | C2/C3 | 5 | |

Photo 5: Deterioration & Cracking at Existing Concrete Floor Slab.

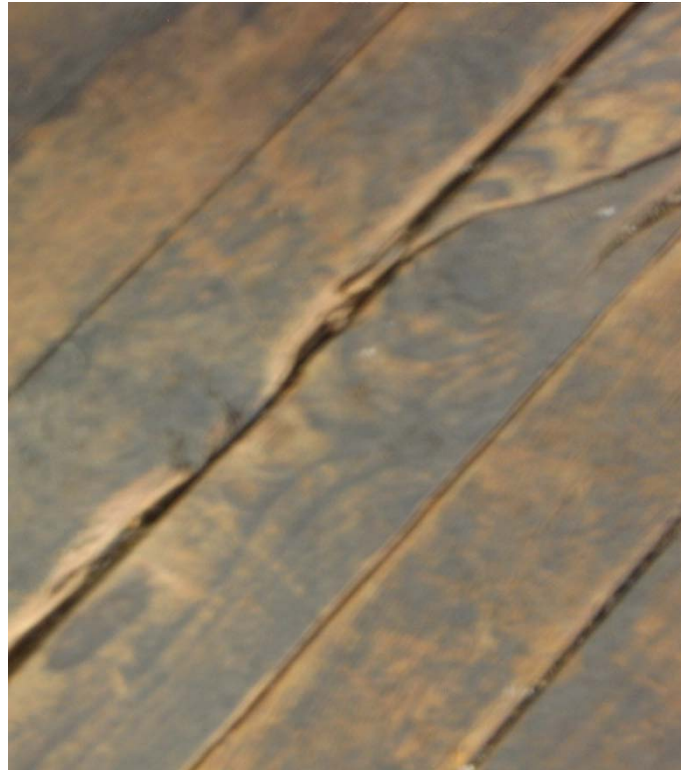
| INTERIOR ITEM | PROBLEM IDENTIFIED | PROBLEM LOCATION | | | | | | | | | | | | | | | | | | | | | | | | | | | | RCMD | PHOTO |
|--|---|---|---|---|---|---|---|---|---|---|---|---|---|---|---|---|---|---|---|---|---|---|---|---|---|---|---|---|---|---|---|
| Wood Roof Framing | Deterioration of Existing Wood Roof Framing - Minor | | | | | | | | | | | | | | | | | | | | | ● | ● | ● | ● | ● | ● | | W2 | 6, 8 | |

Photo 6: Deterioration of Exterior Wood Roof Boards.

MODERATE REPAIRS ARE NEEDED FOR ROOF FRAMING AND ASSOCIATED ROOF BOARDS. MINOR DETERIORATION OF THE EXISTING ROOF FRAMING & ASSOCIATED FLOOR BOARDS WAS FOUND AS NOTED BELOW.

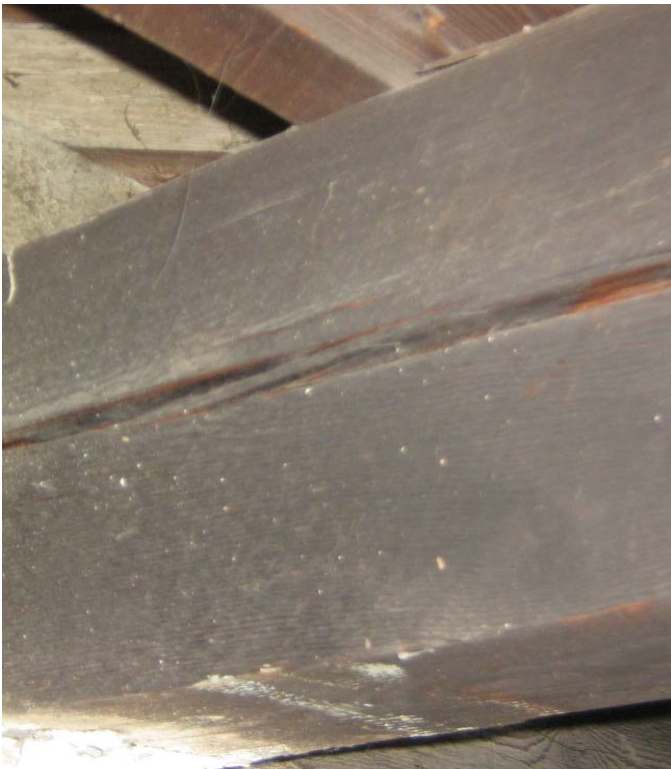
| INTERIOR ITEM | PROBLEM IDENTIFIED | PROBLEM LOCATION | | | | | | | | | | | | | | | | | | | | | | | | | | | | RCMD | PHOTO |
|--|---|---|---|---|---|---|---|---|---|---|---|---|---|---|---|---|---|---|---|---|---|---|---|---|---|---|---|---|---|---|---|
| | Deterioration of Wood Floor Framing - Moderate | | | | | | | ● | ● | ● | ● | ● | ● | | | | | | | | | | | | | | | W3 | 7 | | |

Photo 7: Deterioration of Existing Wood Beam & Associated Floor Framing.

MODERATE REPAIRS ARE NEEDED FOR THE FIRST FLOOR FRAMING AND ASSOCIATED FLOOR BOARDS. MINOR DETERIORATION OF THE EXISTING FIRST FLOOR FRAMING & ASSOCIATED FLOOR BOARDS WAS FOUND AS NOTED BELOW. HOWEVER, THE FOLLOWING TWO ITEMS ARE OF MORE SIGNIFICANT CONCERN AND SHOULD BE ADDRESSED IN THE NEAR FUTURE. FIRST, THERE WAS SIGNIFICANT SPLITTING OF THE EXISTING FIRST FLOOR WOOD SUPPORT BEAMS. IN ADDITION, A SIGNIFICANT 'SAG' & STRUCTURAL DEFLECTION WAS NOTED IN THE AREA OF THE SECOND FLOOR 'SLEEPING' PORCHES. IN BOTH OF THESE INSTANCES, THESE ITEMS SHOULD BE ADDRESSED IN THE NEAR FUTURE TO PREVENT FURTHER STRUCTURAL DETERIORATION.

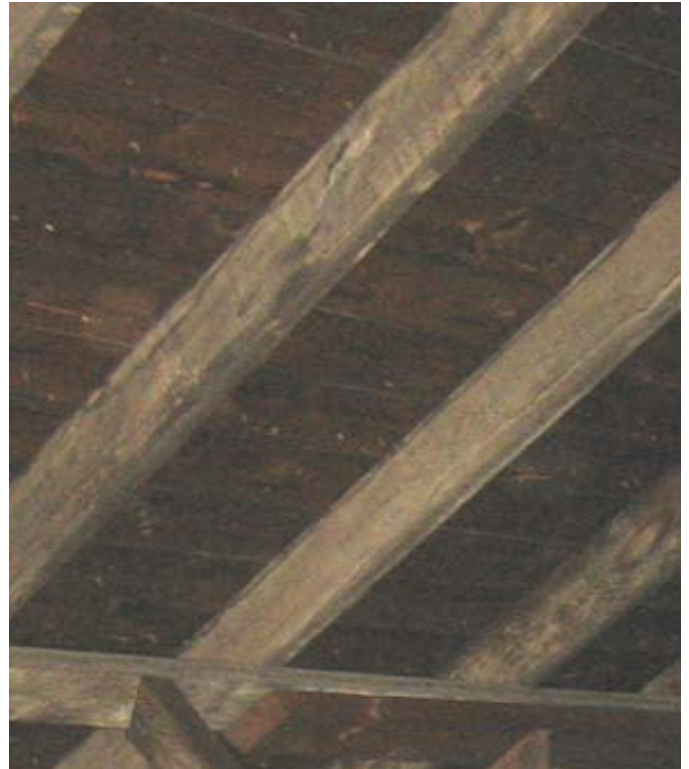
Photo 8: Deterioration of Existing Wood Roof Framing & Associated Roof Boards.

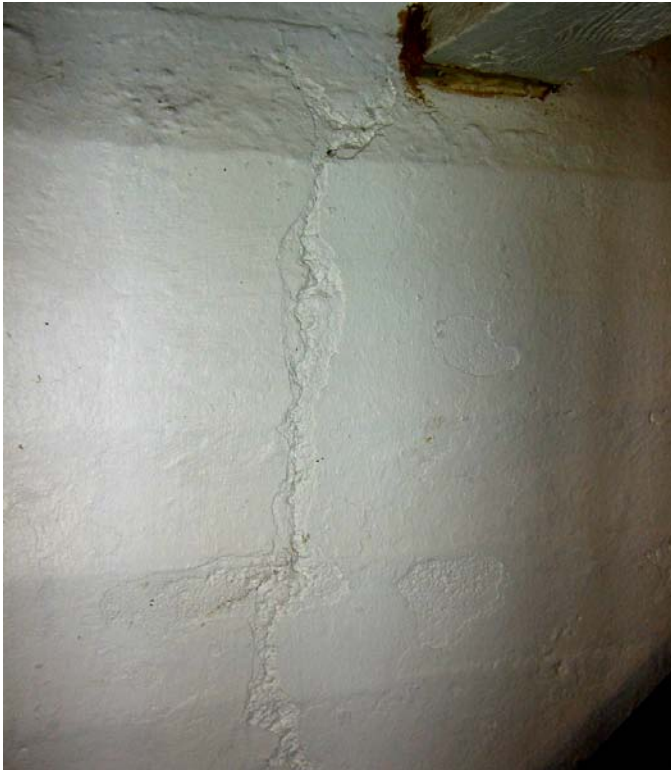
| INTERIOR ITEM | PROBLEM IDENTIFIED | PROBLEM LOCATION | | | | | | | | | | | | | | | | | | | | | | | | | | | | RCMD | PHOTO |
|--|---|---|---|---|---|---|---|---|---|---|---|---|---|---|---|---|---|---|---|---|---|---|---|---|---|---|---|---|---|---|---|
| Structural Walls - Concrete | Wall Cracking - Minor | ● | ● | ● | ● | | | | | | | | | | | | | | | | | | | | | | | | C2 | 9 | |

Photo 9: Deterioration & Cracking at Existing Concrete Foundation Walls.

MODERATE REPAIRS ARE NEEDED FOR ALL THE FOUNDATION WALLS AS MINOR CRACKING TO THE EXISTING CONCRETE FOUNDATION WALLS HAS TAKEN PLACE.

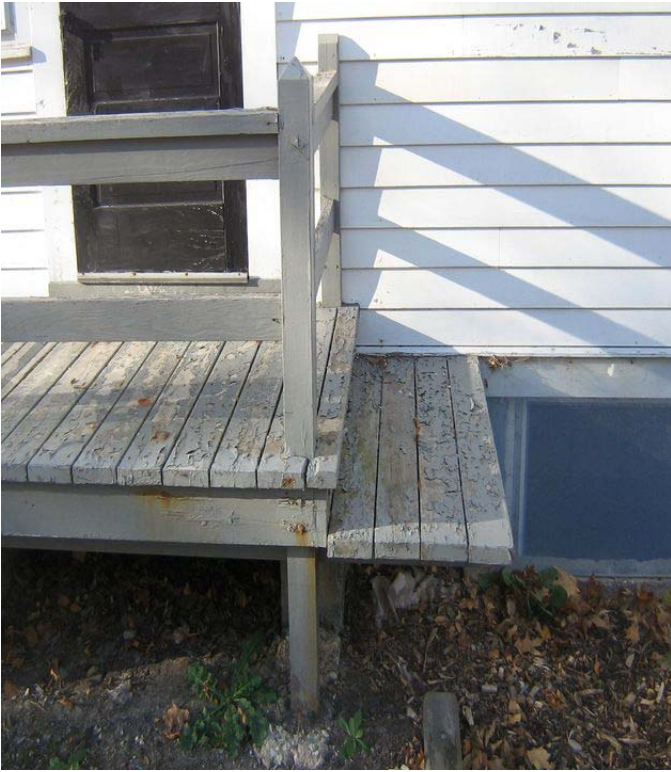
1 Peeling paint on wood clapboards and stairs.

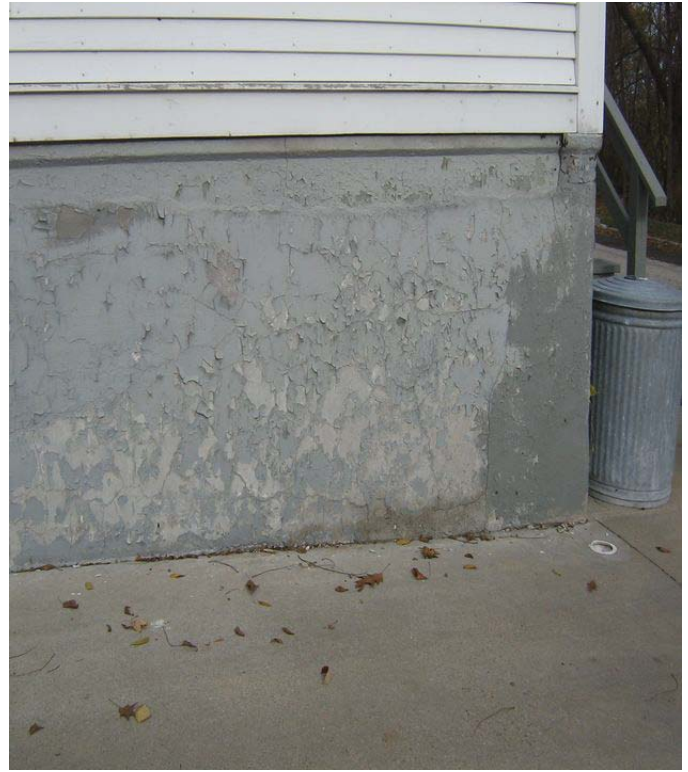
| EXTERIOR ITEM | PROBLEM IDENTIFIED | PROBLEM LOCATION | | | | | | | | | | | | | | | | | | RCMD | PHOTO | |
|---|---|---|---|---|---|---|---|---|---|---|---|---|---|---|---|---|---|---|---|---|---|---|
| | on foundation walls | ● | ● | ● | ● | | | | | | | | | | | | | | | | LBP1 | 2 |

2 Peeling paint on foundation walls.

Paint which has begun to peel due to a failure of the bond to the wood, plaster, or metal substrate should be removed. Paint is best removed with the careful use of metal scrapers. Sanding is usually required to eliminate rough surfaces and to smooth the transition between areas of raw wood and solid original painted surfaces. Before repainting, all raw surfaces should be primed with a tested and approved primer. This treatment should then be followed by required coat(s) of paint of the type and color to match the surrounding area. All activities must be conducted in a manner consistent with the requirements provided in 29 CFR 1926.

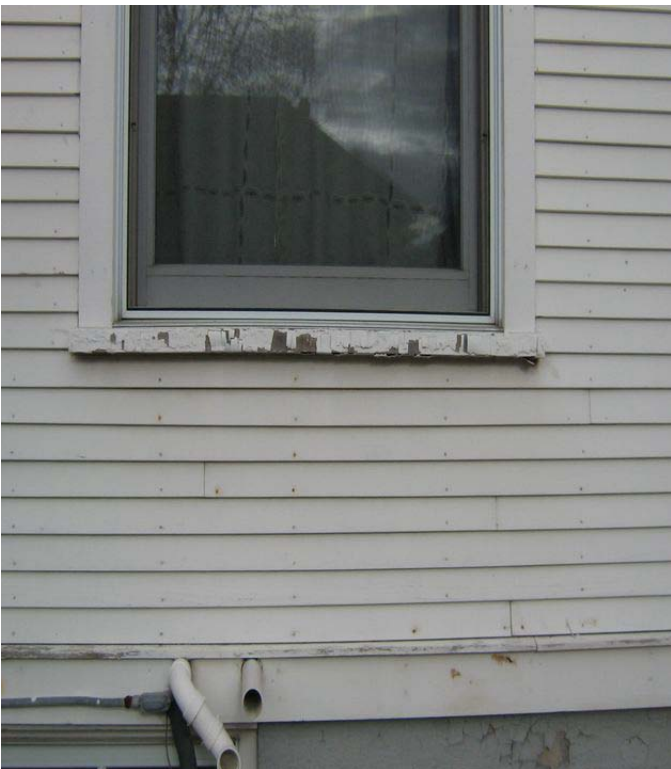
3 Peeling paint on window frame.

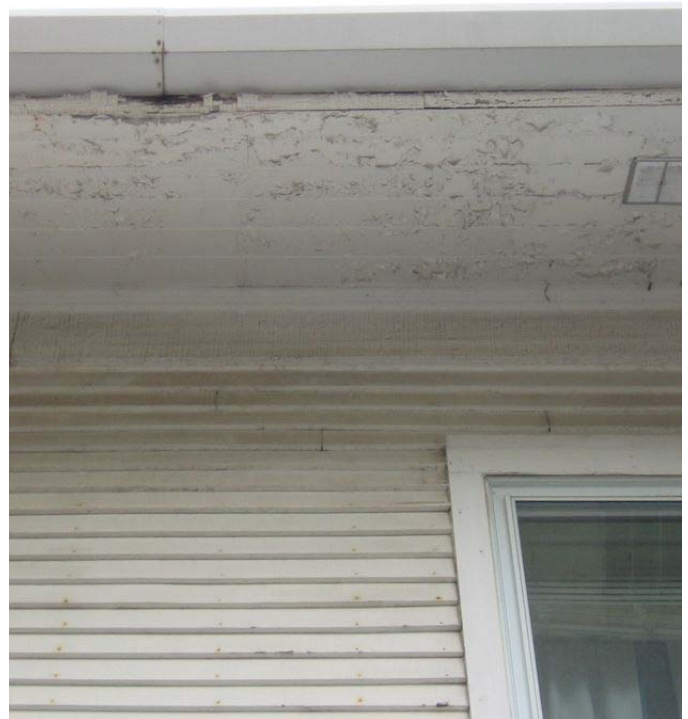
4 Peeling paint on eaves/trim.

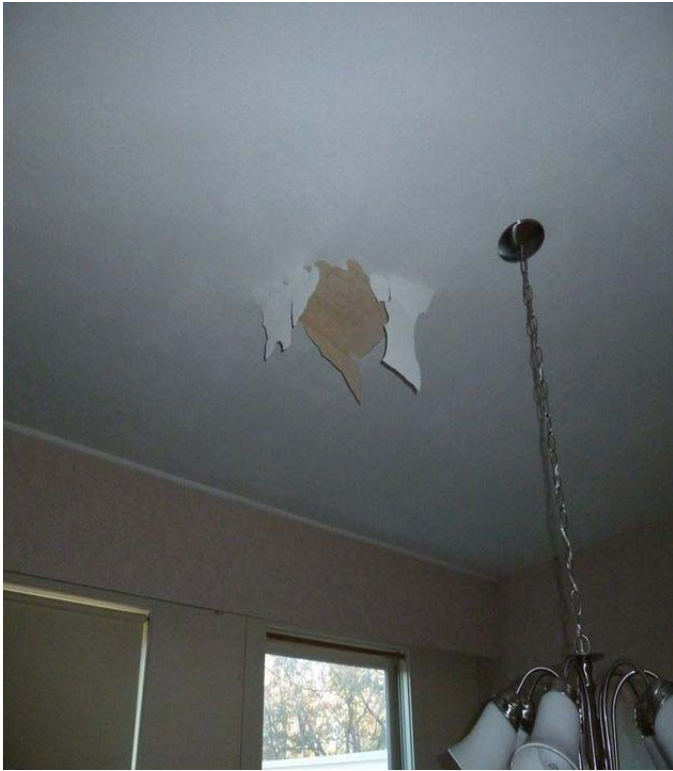
5 *Peeling paint on ceiling.*

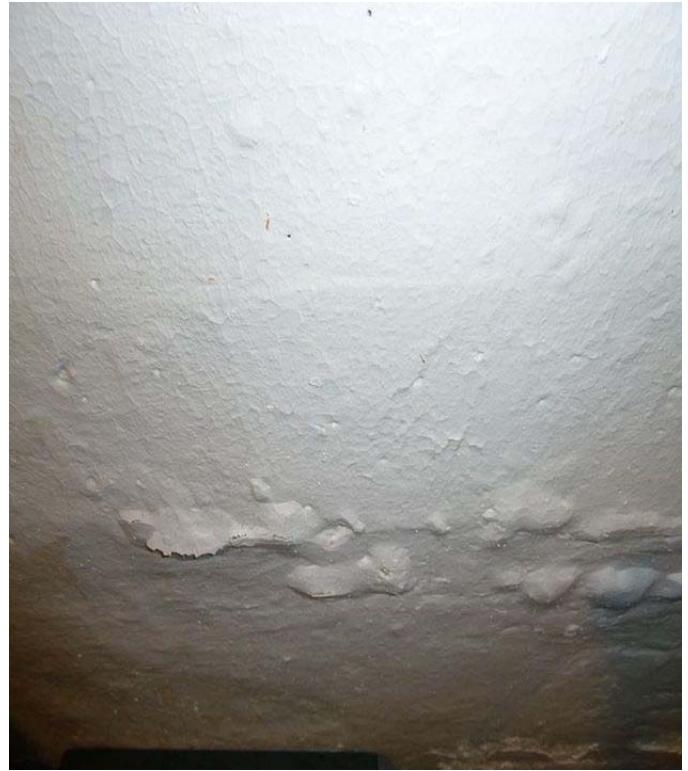
6 *Peeling paint on wall.*

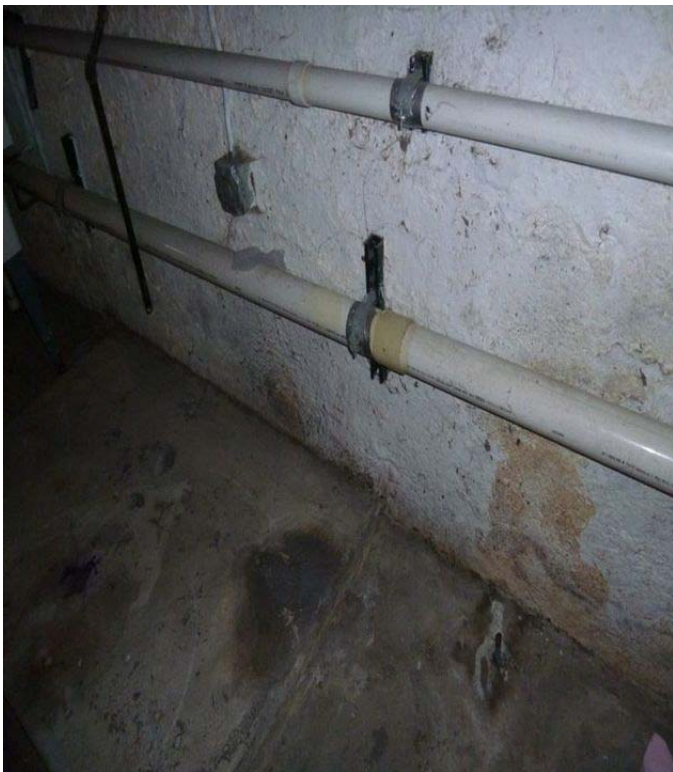
| INTERIOR ITEM | PROBLEM IDENTIFIED | PROBLEM LOCATION | | | | | | | | | | | | | | | | | | RCMD | PHOTO |
|---|---|---|---|---|---|---|---|---|---|---|---|---|---|---|---|---|---|---|---|---|---|
| | wall | • | • | | | | | | | | | | | | | | | | | M02 | 7 |
| | floor | • | • | | | | | | | | | | | | | | | | | M02 | 7 |

7 *Discoloration of walls and floors in basement.*

Suspect mold growth and stained building materials implies that there is or has been water intrusion or leaks or the relative humidity within the building was high enough to cause localized or widespread condensation. It is recommended that the moisture source be located and corrected, if this has not already taken place, remove fungal-impacted building materials, and replace or repair the water stained materials.

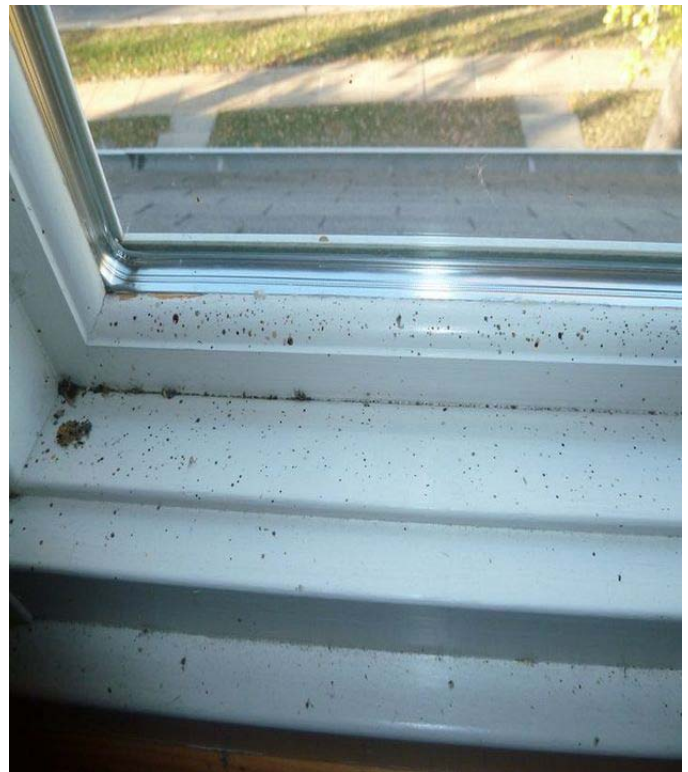
Suspect mold growth was visually observed on window frames in the attic. See the **'Hazardous Materials Maintenance Treatment Plan - Exterior'** and **'Hazardous Materials Maintenance Treatment Plan - Interior'** for locations of affected areas noted above.

8 *Suspect mold growth on window frame.*

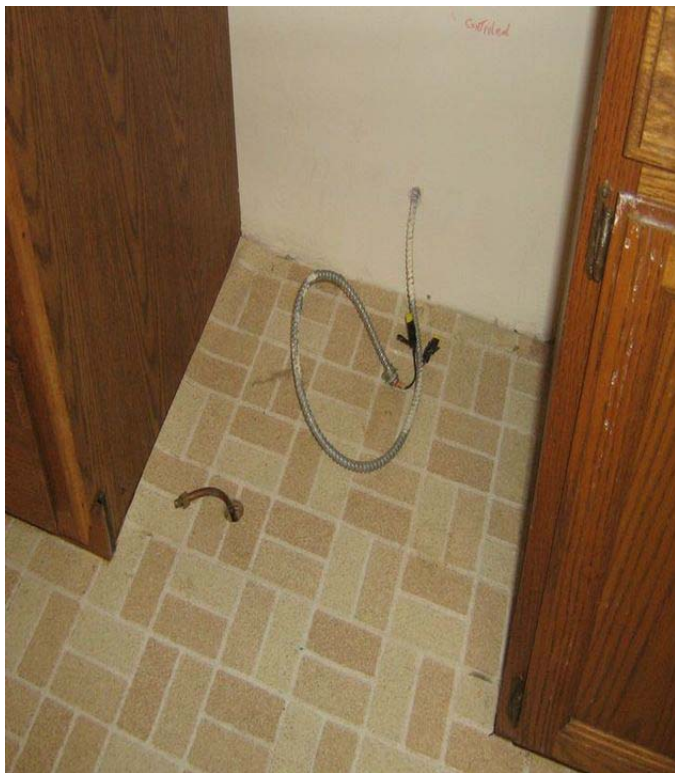
| INTERIOR ITEM | PROBLEM IDENTIFIED | PROBLEM LOCATION | | | | | | | | | | | | | | | | | | RCMD | PHOTO |
|---|---|---|---|---|---|---|---|---|---|---|---|---|---|---|---|---|---|---|---|---|---|
| Asbestos | damaged, peeling vinyl flooring | | | • | • | | | | | | | | | | | | | | | AS01 | 9 |

9 *Peeling vinyl flooring in kitchen.*

Vinyl flooring located in the kitchens of both north and south units showed evidence of peeling and should be repaired. Friable thermal insulation located in the attic is exposed and should be contained to prevent further exposure or damage. See the **'Hazardous Materials Maintenance Treatment Plan - Exterior'** and **'Hazardous Materials Maintenance Treatment Plan - Interior'** for locations of affected areas noted above. All activities involving asbestos or materials assumed to contain asbestos should be conducted in accordance with all local, state and federal rules and regulations.

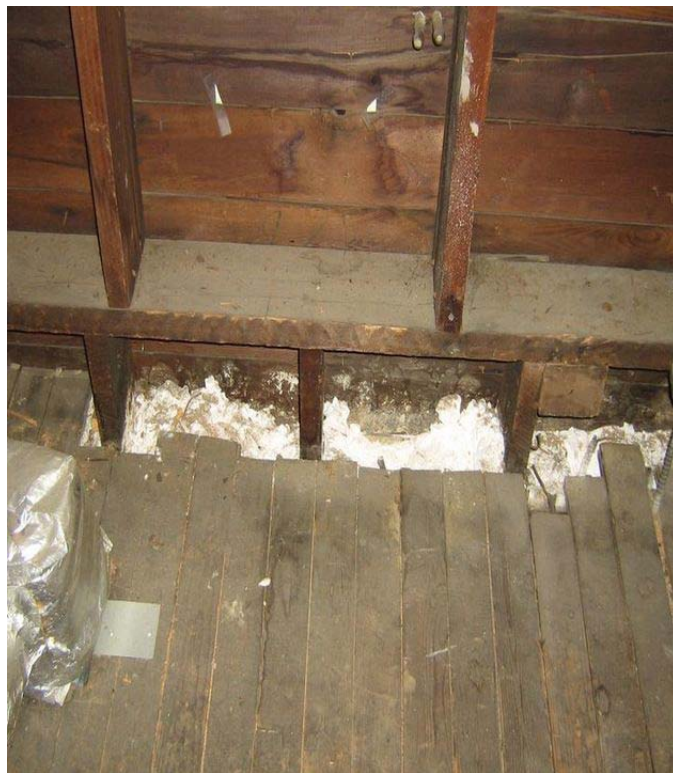
10 *Exposed friable insulation in attic.*
